Manhole Inspection Summary

Manhole # S29KK_050MH

Insp Date: **7/18/07 10:40 AM**

Location Address: **1805 PARK AVE**

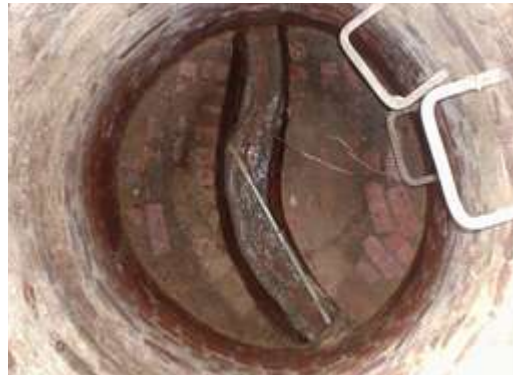
Top View

☒ **Evidence Of Surcharge** Depth: **1** (ft.) ☐ Active Surcharge Present

Evidence of surcharge - Bench debris.

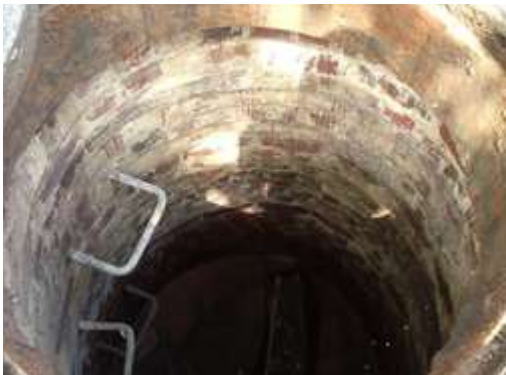
Defect

Condition: ☐ Sound ☐ Cracked ☒ **Leaks**

Infiltration: ☐ None ☐ Joint ☐ Cracks ☒ **Mortar** ☐ Roots ☒ **Wall**

Frame leaks. Adjustment, Corbel and Barrel infiltration - other side.

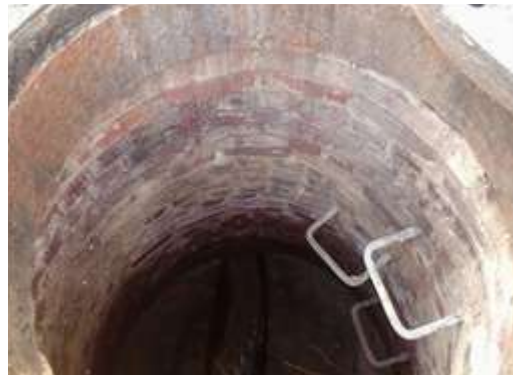
Defect

Infiltration: ☐ None ☒ **Joint** ☐ Cracks ☒ **Mortar** ☐ Roots ☐ Wall

Frame leaks. Adjustment, Corbel and Barrel infiltration.

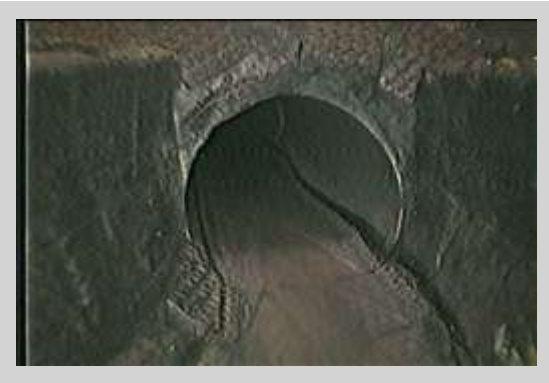
8 in. Circular Gravity Sewer Pipe Out @ 12 O'Clock

Infiltration: **Evidence** Pipe Seal Cond: **Unknown**

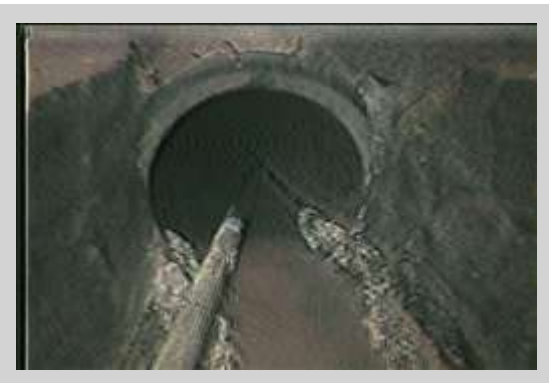
8 in. Circular Gravity Sewer Pipe In @ 6 O'Clock

Deposits: ☐ None ☐ Mud ☐ Sludge ☐ Debris ☒ Grease

Silt Depth: **0** (in.) Deposits Extent: **Light**

Infiltration: **Evidence** Pipe Seal Cond: **Cracked**
